Reference: 017052.100

July 20, 2017

**Subject:      Landslide Mitigation Assessment, Trinidad Memorial Lighthouse and  
                 Edwards Street, Trinidad, California**

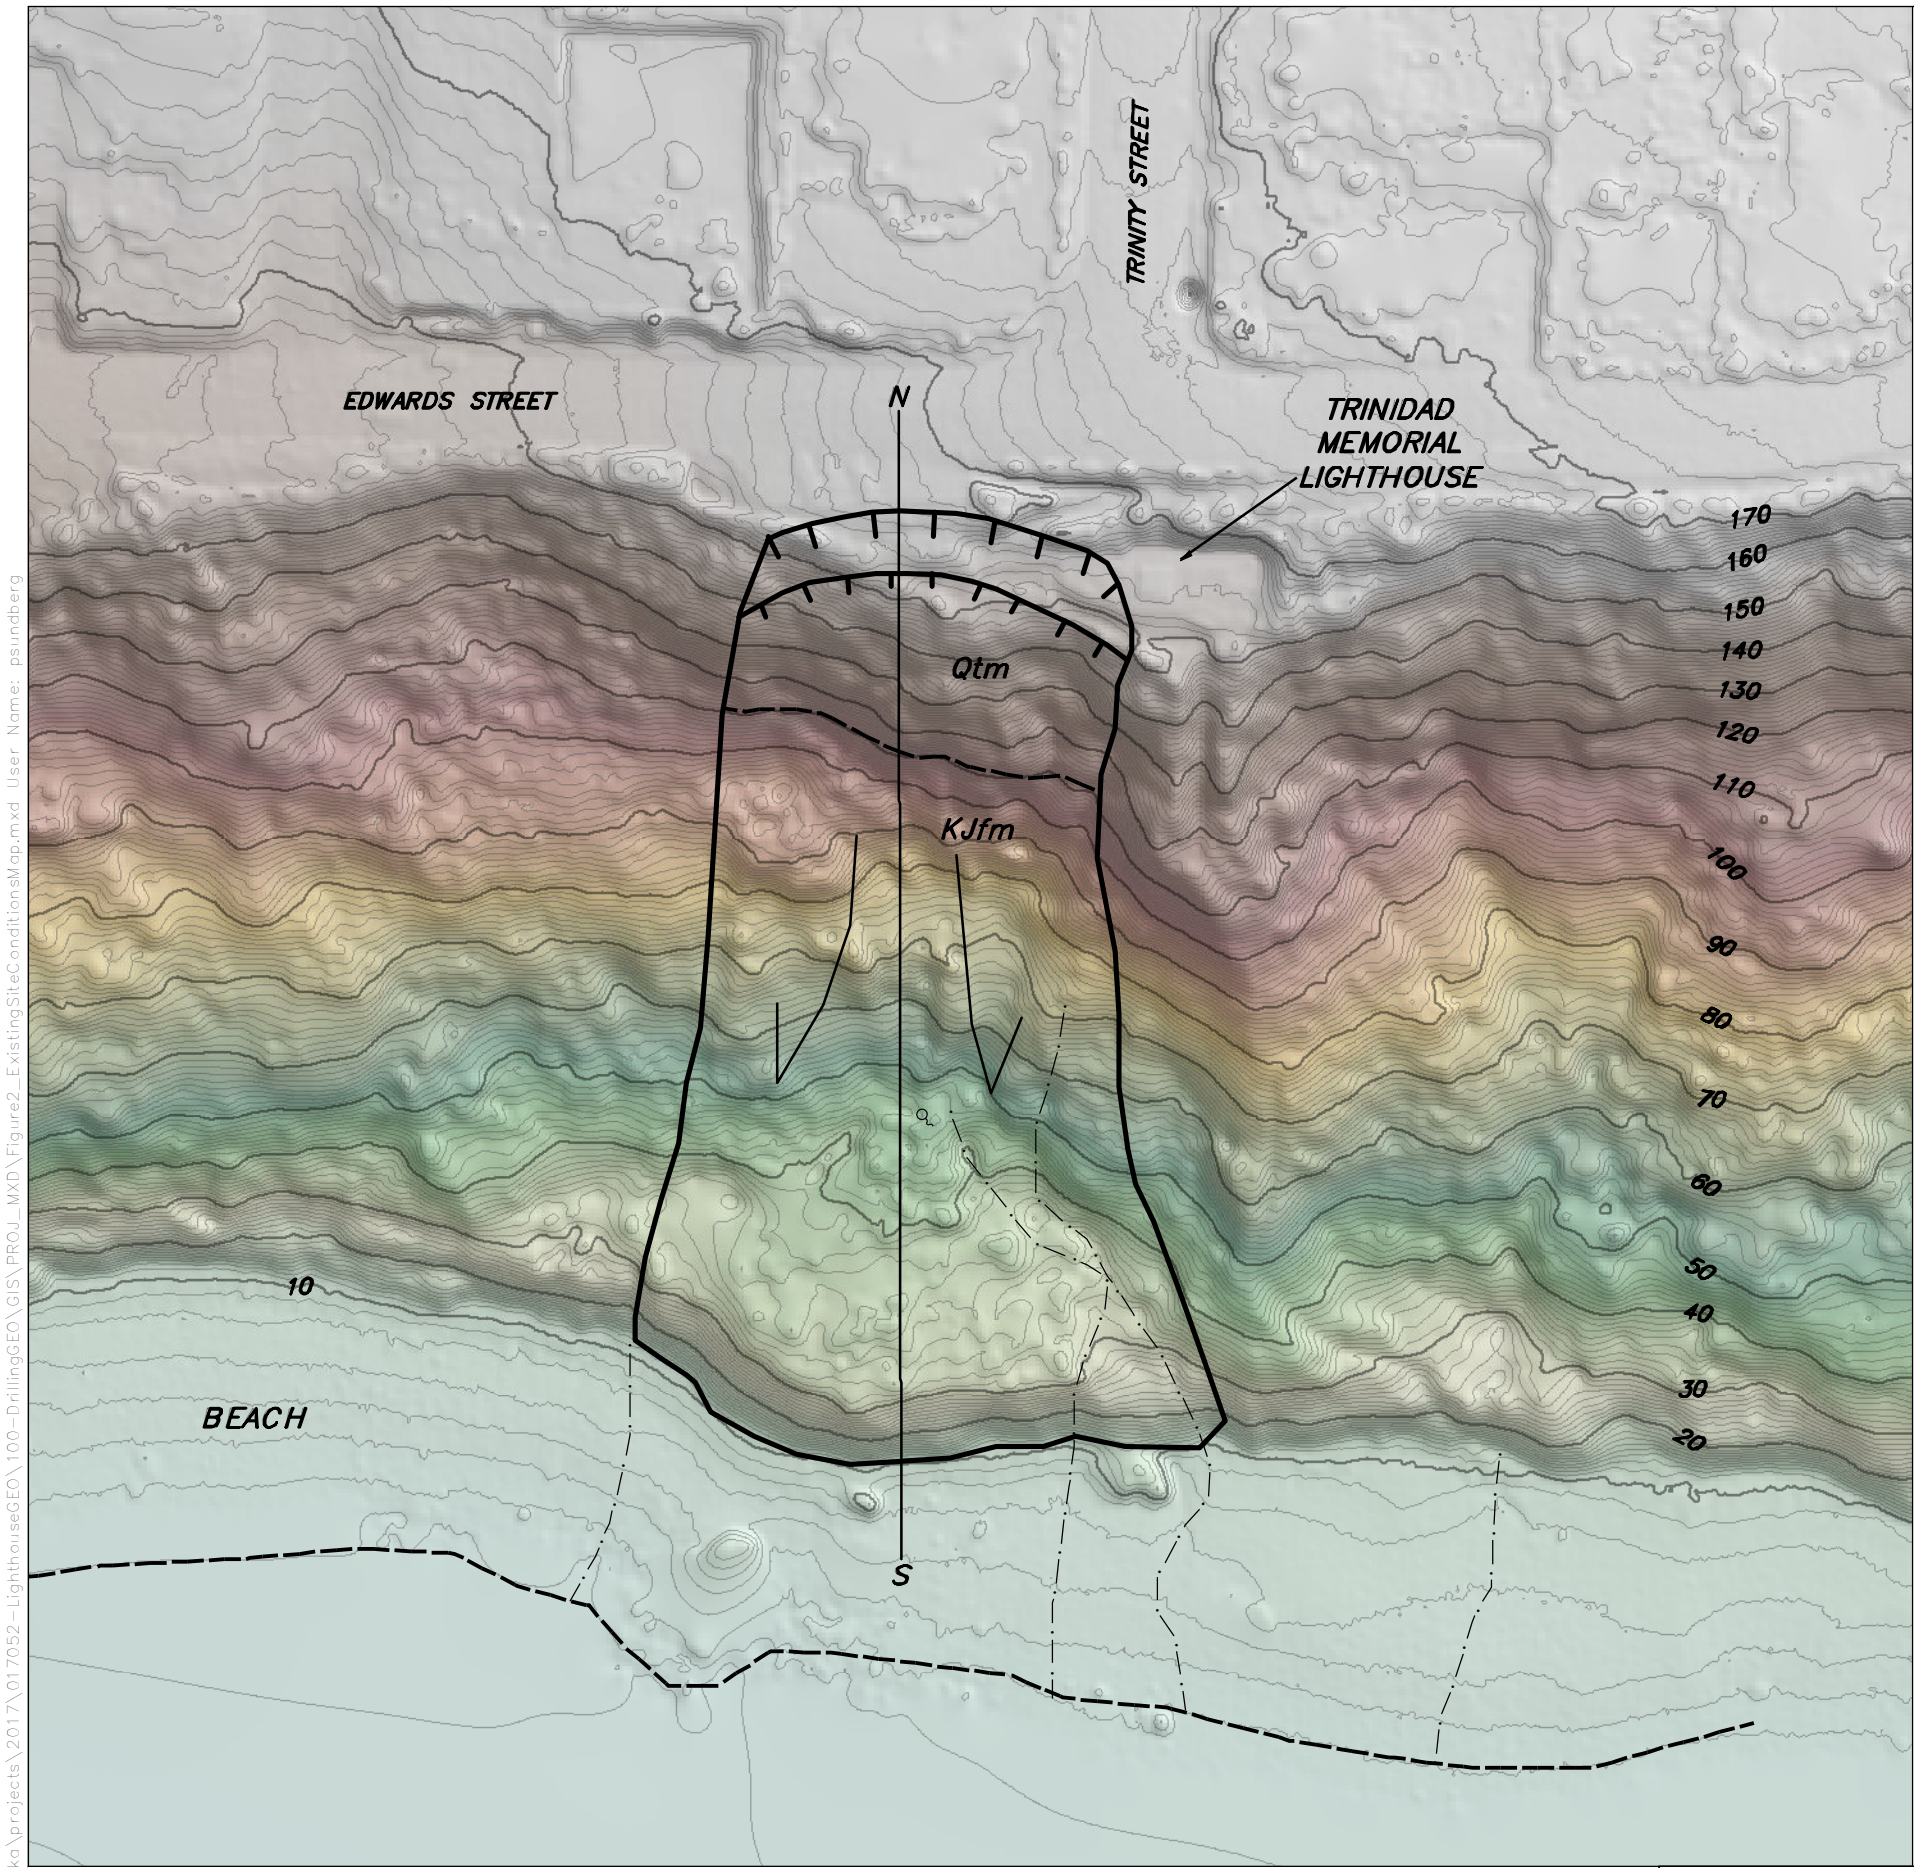
The upper limits of recent landsliding at the site are actively deforming the outer 25 feet of the bluff top along multiple slip surfaces. The main head scarp at the points where it intersects the bluff edge at the main break in slope measures up to 100 feet wide. Lateral margins farther downhill are not apparent; they are obscured by thick vegetation. We assume that the nested failure planes sole (detach at a low angle) into a single slide plane at depth. The slide plane is interpreted to be confined to the marine terrace sands that overlie the mélange bedrock and would, theoretically, daylight along the slope face about 45 to 50 feet in elevation below the bluff edge. The maximum width of the body of the entire landslide complex is approximately 140 feet

midslope, and is assumed to extend a ground distance of about 400 feet down slope from the bluff edge, as shown on Figure 2.

Slope stability analyses were performed using computer software (SLIDE 7.0) and the slope profile line depicted on Figure 2. The output for the model of the existing failure condition was determined using the Spencer method and a fully specified failure surface. (This is a simplified three-layer model in which soil and bedrock strength parameters were back calculated with an interpreted piezometric groundwater surface, to achieve a factor of safety of 1.0.) The assumed depth of the failure plane was estimated to be approximately 25 feet BGS at the location of the bluff edge. The effective geotechnical parameters for the slide materials are phi (angle of internal friction) equal to 28 and 30 degrees, cohesion equal to zero (0) pounds per square foot (psf), and saturated unit weight equal to 120 and 130 pounds per cubic foot (pcf). The shear strength of the bedrock was modeled as 5,000 psf with saturated unit weight equal to 144 pcf.

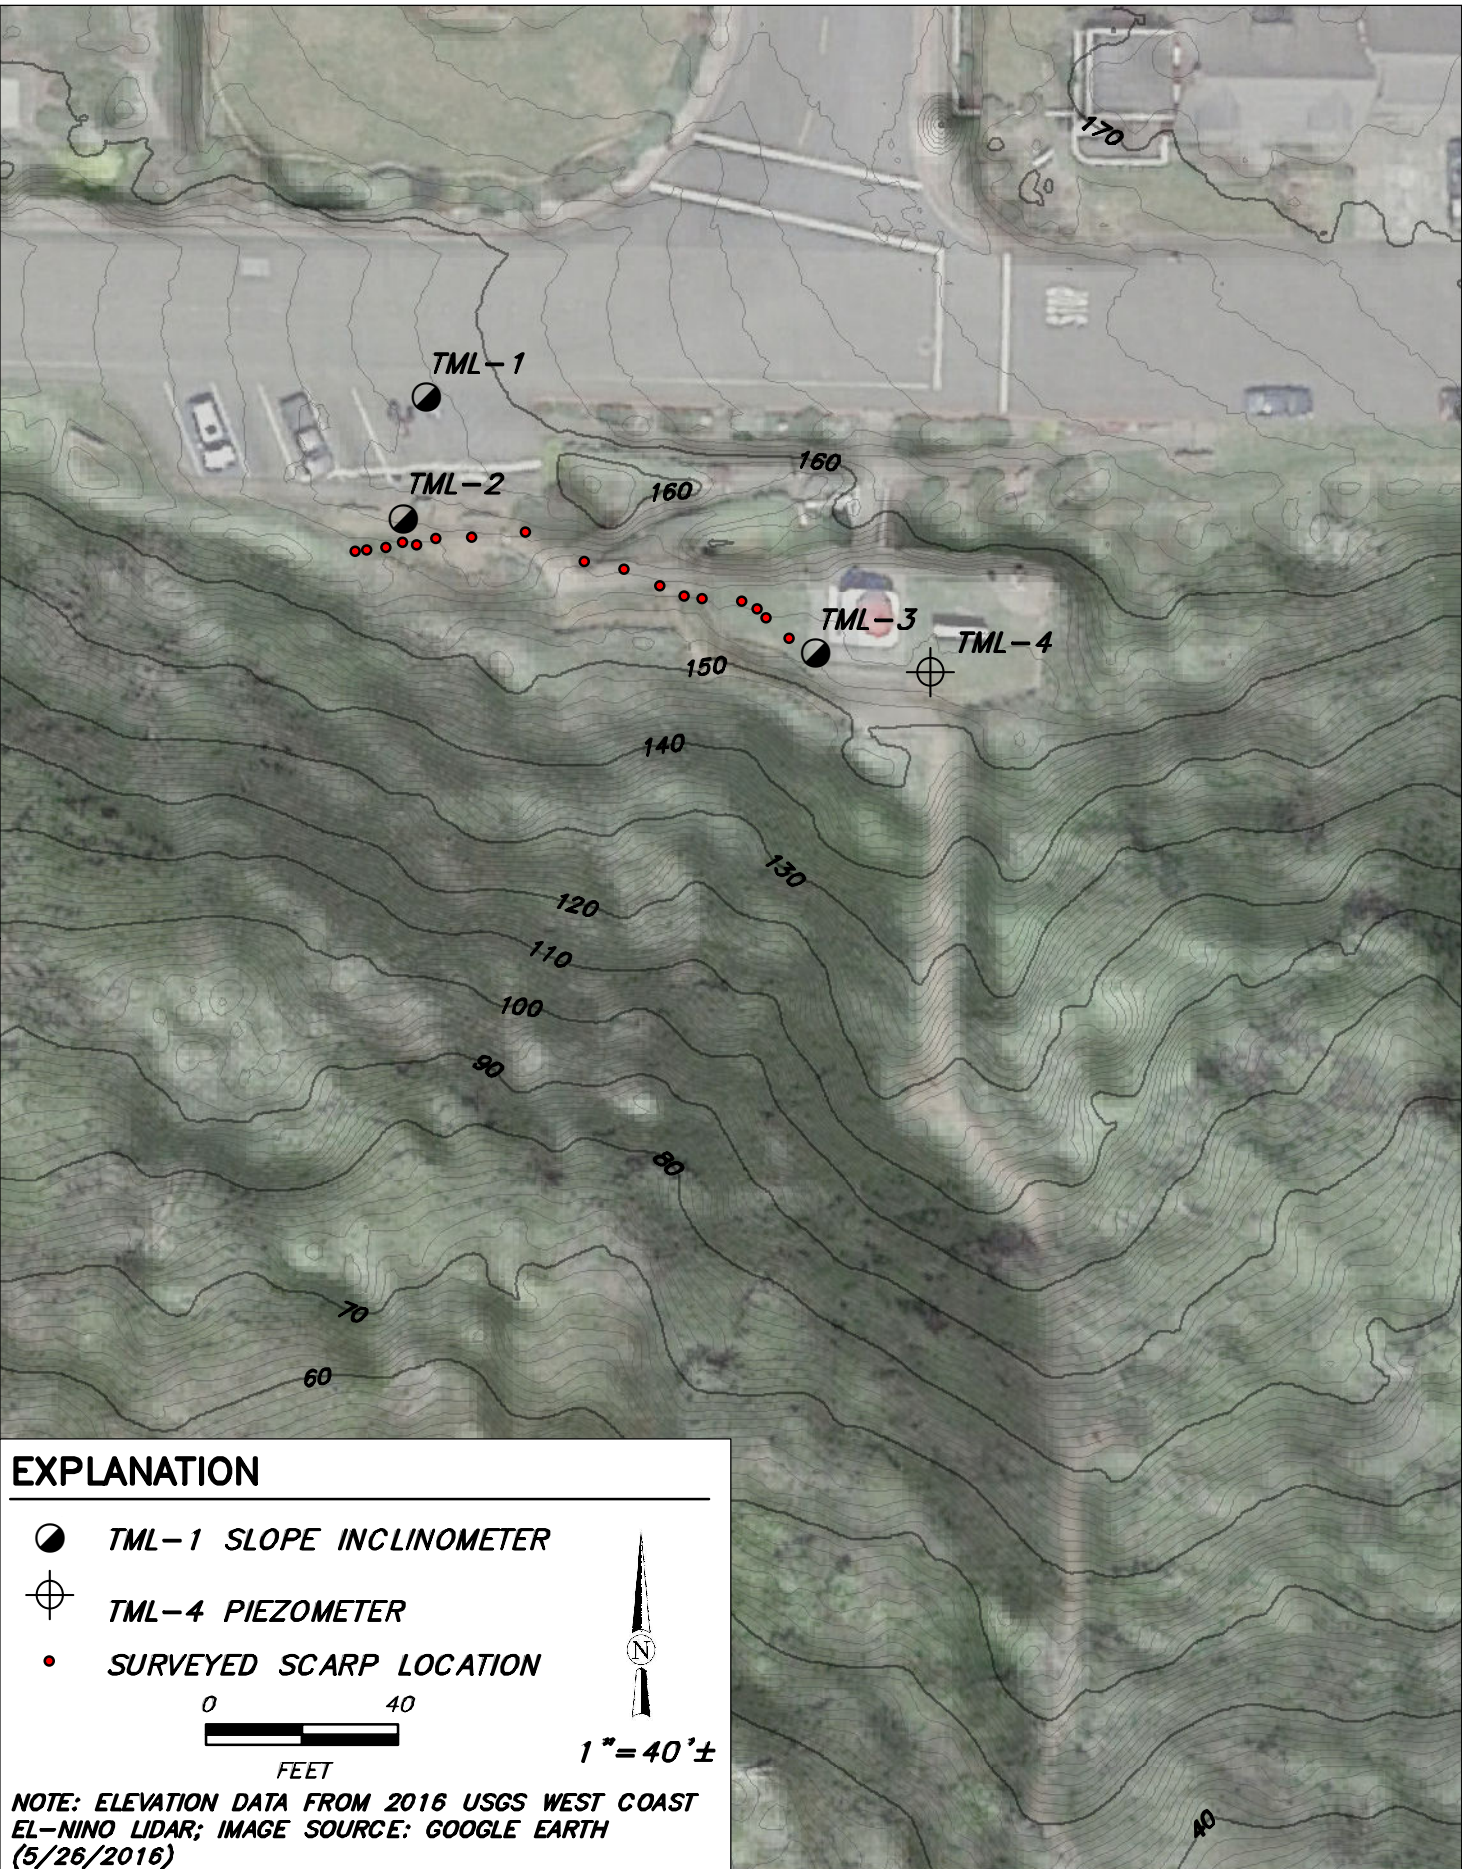
<p>SHN Consulting Engineers &amp; Geologists, Inc.</p>	<p>City of Trinidad Landslide Mitigation Assessment Trinidad, California</p> <p>July 2017</p>	<p>Boring Location Map SHN 017052.100</p> <p>Figure3_BoringLocationMap</p>	<p>Figure 3</p>
--	---	--	-----------------

On May 3 and 4, 2017, four geotechnical borings, denoted as TML-1 through TML-4, were drilled at the locations shown on Figure 3. The borings were drilled to assess soil conditions, determine the depth to bedrock and the slide plane, and to make a direct measurement of the groundwater elevation at the time of drilling. The borings were drilled and sampled to depths of up to 51 feet below the existing ground surface (BGS) by Taber Drilling of West Sacramento, California. Borings were advanced using both a truck-mounted and limited-access track-mounted drilling rig outfitted with 6 $\frac{5}{8}$ -inch diameter hollow stem augers and 4-inch diameter solid flight augers.

Boring TML-1 was drilled at the outboard edge of Edwards Street and is located to the landward (upslope) side of the main head scarp and active slide mass. The boring was drilled to a depth of 50 feet BGS and was located primarily to assess the material strength of the undeformed terrace deposits. Boring TML-2 was drilled to a depth of 51 feet BGS immediately downslope of the main head scarp near the apex of the active slide mass. Boring TML-3 was drilled to a depth of 35 feet BGS and is located near the southwest corner of the concrete sidewalk surrounding the lighthouse. Slope inclinometer casing consisting of 2.75-inch outside diameter PVC was constructed in each of these boreholes to monitor landslide movements and determine the depth(s) to the slide planes. The slope inclinometer in TML-1 is intended to be used for future monitoring in order to assess whether or not the landslide is retrogressing upslope and beneath Edwards Street. One additional boring was drilled to a depth of 35 feet BGS east of the lighthouse. The boring was converted to a piezometer constructed of 1½-inch PVC pipe with factory-screened 0.010 slot in order to measure groundwater levels. All borings were completed with traffic-rated well boxes at the ground surface to protect the top of the casings and for ease of access for future monitoring.
